STEEL WORK

STEP 1 - Situation: Head on Collision, Damaged area Forecastle Peak and all surrounding areas and internals, furthermore vessel was loaded with cargo for Transportation to South America, that was urgently required. This was even more difficult as Dry dock was not available during the Christmas period.

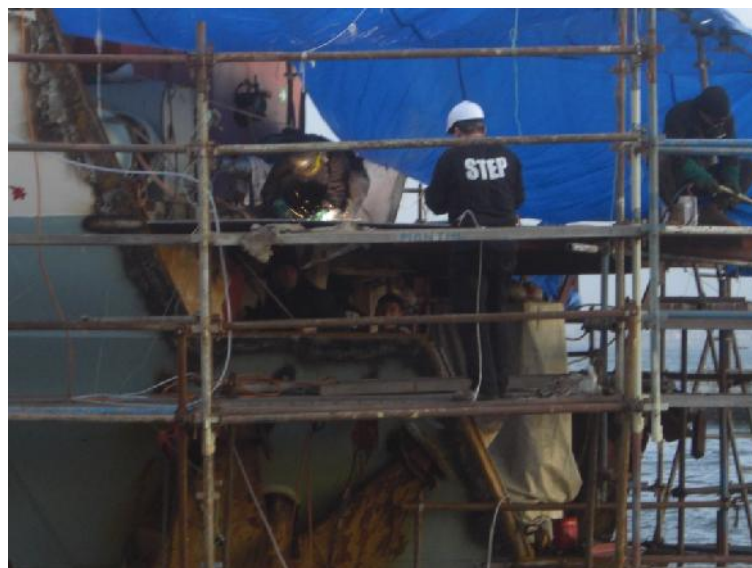
STEP 2 - Challenge: To fabricate and repair within charter delivery timeframe, No drawings available. Area of repair with difficult access.
