## ALTERNATOR OVERHAUL

Requested an Alternator Overhaul for the Guanaterme vessel.

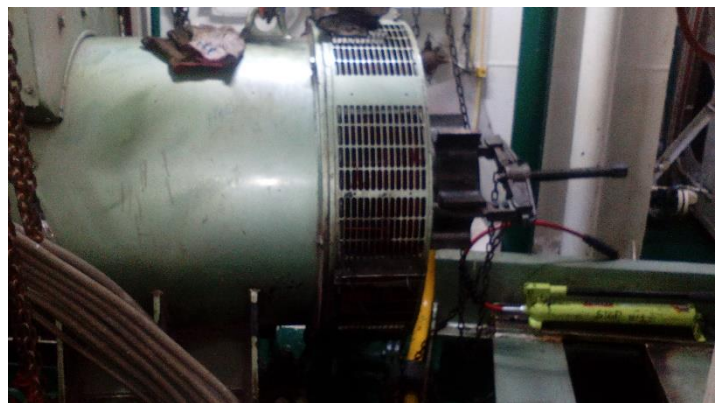
No. 2 Alternator Overhaul; Replace of bearings; Rotor and stator cleaning; Coupling diodes checking.

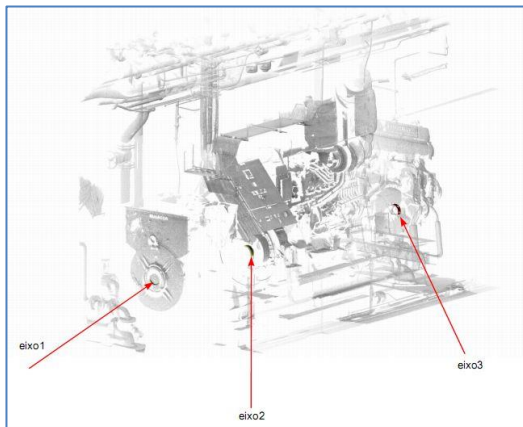
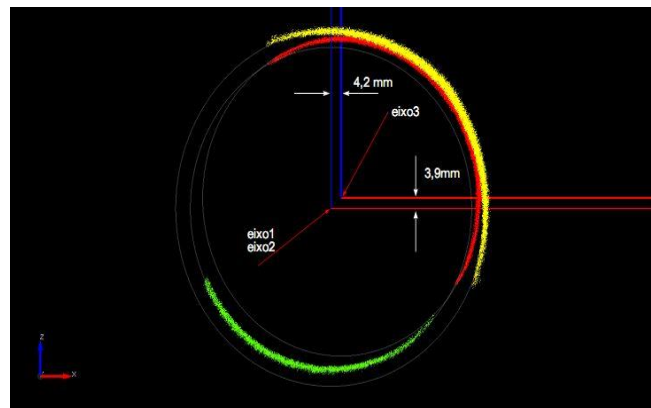
Misalignment of 3,9mm in the axis 3 and longitudinal 4,2 mm

The alignment problem was originated by a unscrewed blocking bolt that affected the stability of the system. This cause an increase of the natural vibration, causing the alignment problem. Situation successfully corrected. All works have been executed as required.

- 3 Removing and installing alternator cover;
- 4 Supply of the resistor for the alternator;
- 5 Perform check-up laser system for detecting the necessary adjustments;
- 6 Alignment shaft by our team, according to the results of laser measurements;
- 7 Perform final measurement after alignment, reinstall all components.

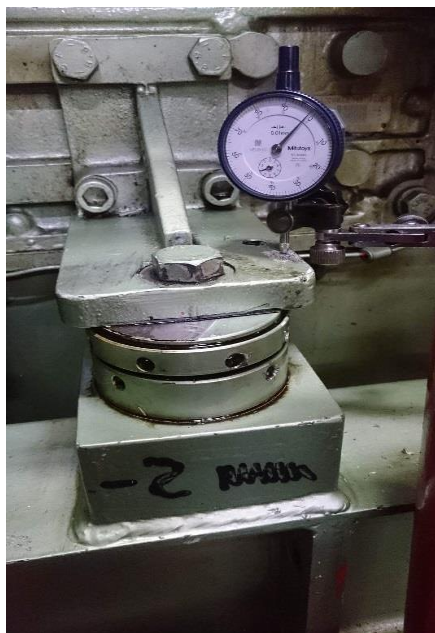
Alignment: 2mm in axis 3

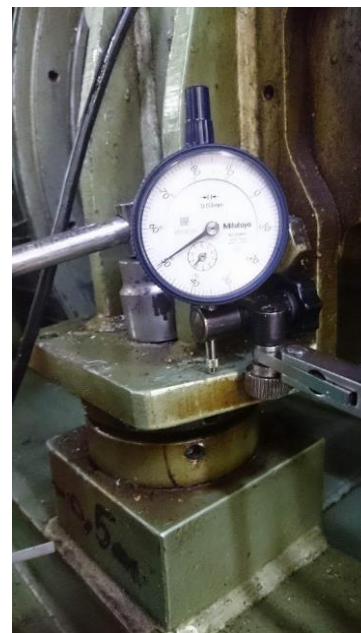
Alignment: 0,5mm in axis 2
