REPAIR AND FABRICATION OF COMBINED EXHAUST GAS BOILER

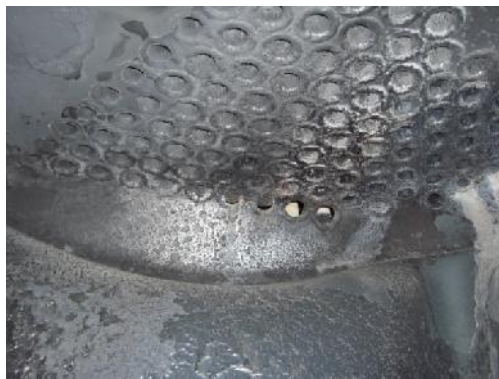
STEP 1 - Situation: arrived onboard Chemical vessel in Southern Spain to inspect Boiler - view through the burner opening quickly revealed that, the furnace had sagged from the sides, Furnace Shell, Bottom Tube plate and waterside boiler tubes had been ripped and melted due to lack of water.

View from Burner Opening

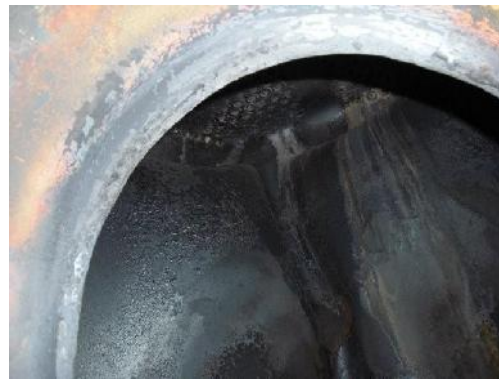
View of Deformed Top TubePlate

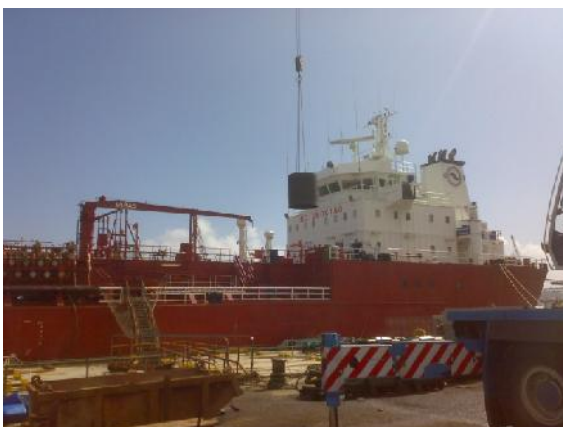
Furnace Plate being delivered

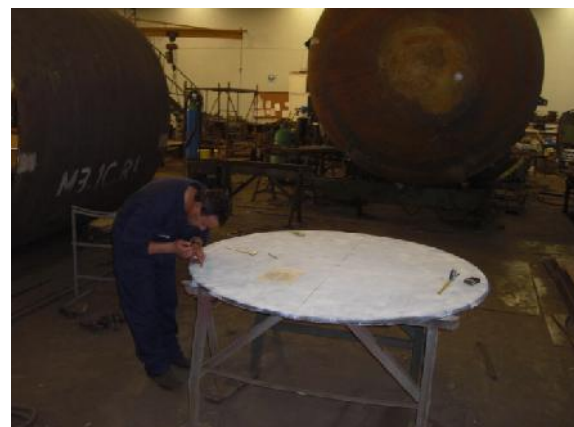
Marking of tube plate in workshop

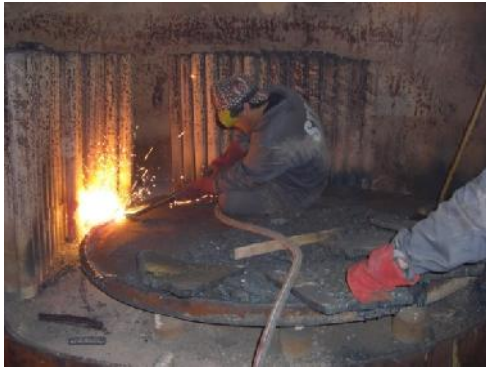
Removal of damaged areas

STEP 3 - Action: Cut and remove all damaged areas, clean and grind out weld up by GTAW and SMAW. Repair procedure to be approved via Manufacturer.

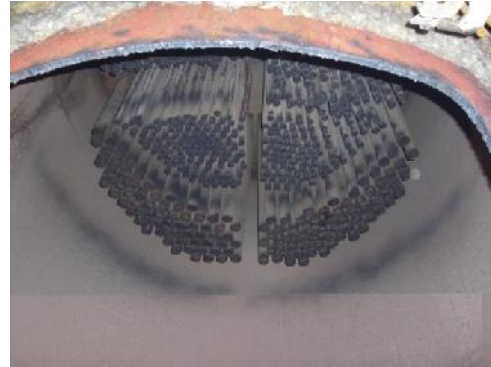
Suspended tubes on Top tube plate

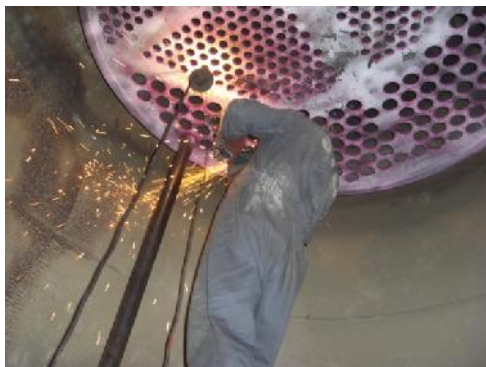
Cleaning and grinding Top Tube Plate

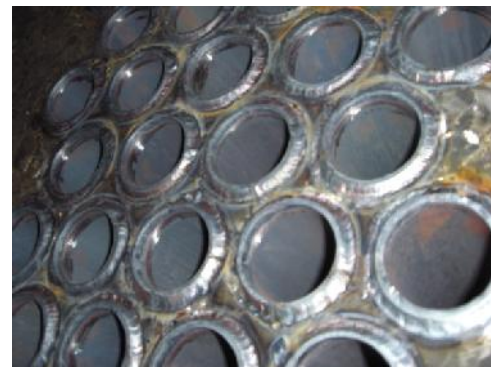
Welded tubes using GTAW and SMAW

- Completion 16 days
- Pressure test approved
- NDT passed and approved
- Class approved
- Manufacturer recommendation on job duration
- Satisfied client
