Burner Cover repair

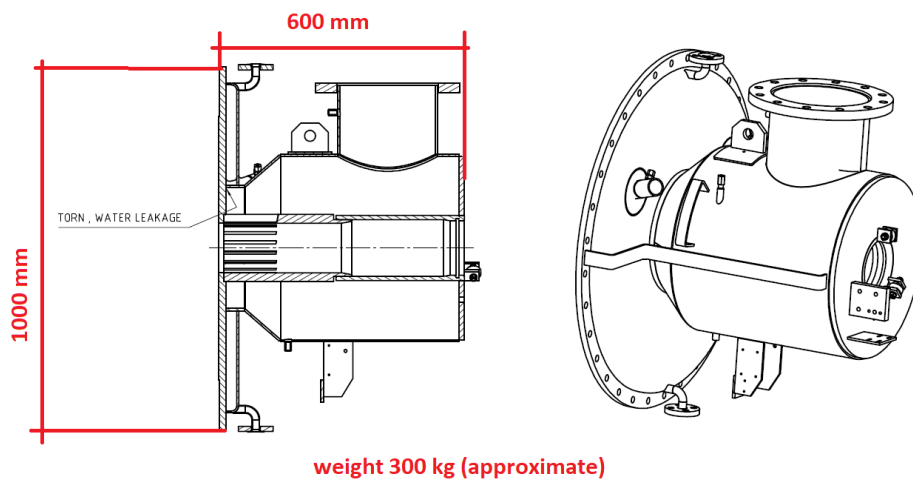
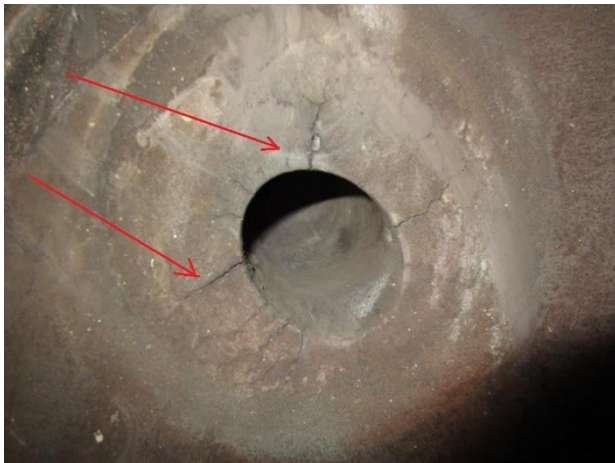
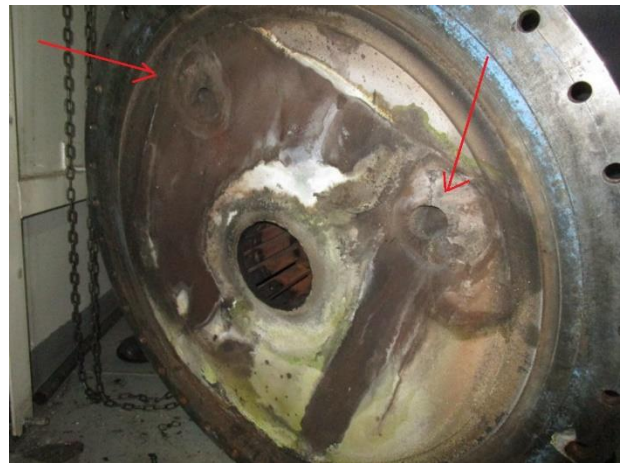
Repair of an IGS Generator Burner Cover as received information.
The Cover had some cracks and the water penetrate the furnace from the cooling chamber.

Visible cracks on the pilot burner hole and peep hole, view from bottom plate of cooling chamber

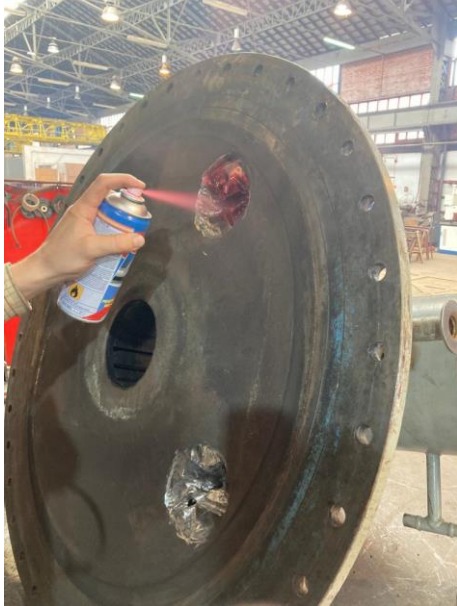
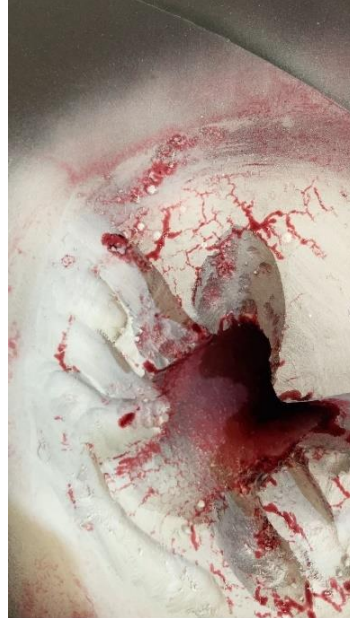
STEP's goal was to identify and successfully repair all cracks. The bottom cover plate was inspected with dye penetrant and found a lot of deep cracks, impossible to remove one by one. Due to material deterioration around the main cracks, it was decided to remove the damaged alloy pieces, replacing the existing pipe branch and re-building a new ones.

A Repair Procedure was previously prepared by STEP and approved by Client.

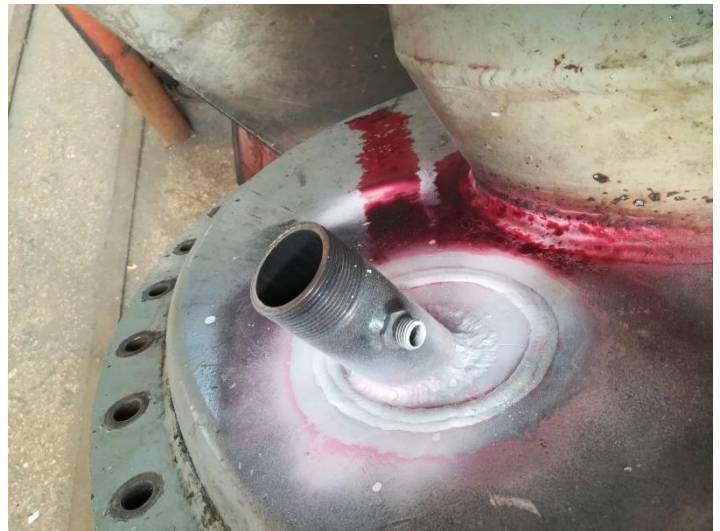
After welding all welds seams were inspected with dye penetrant. No defects were found.

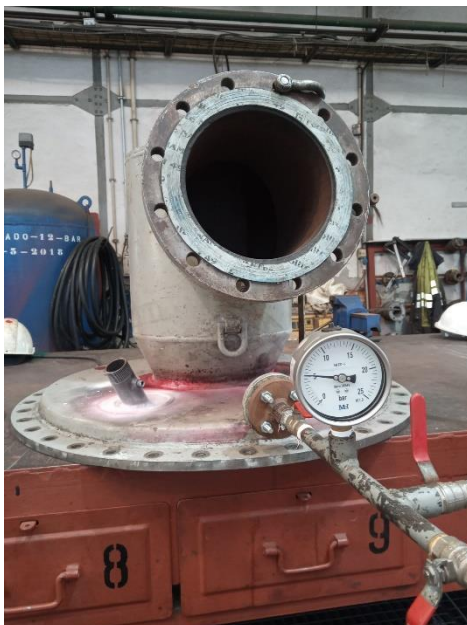
Finally, the hydraulic pressure test. No leaks were detected.
