# Exhaust Boiler repair

Refractory replacement

<b>Site</b>	Lisboa - Portugal
<b>Activity area</b>	Refractory repair
<b>Year</b>	2024

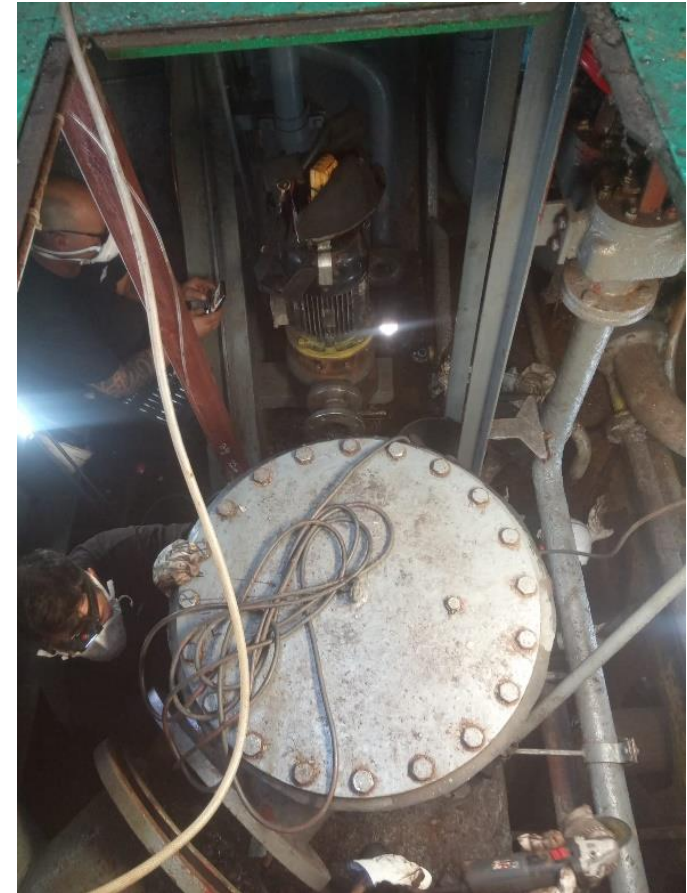
*General view of Boiler on board vessel*

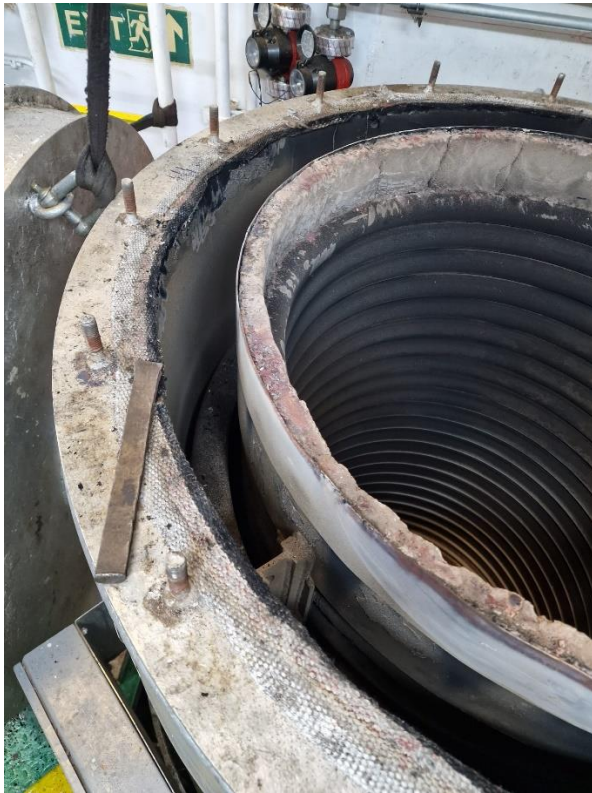
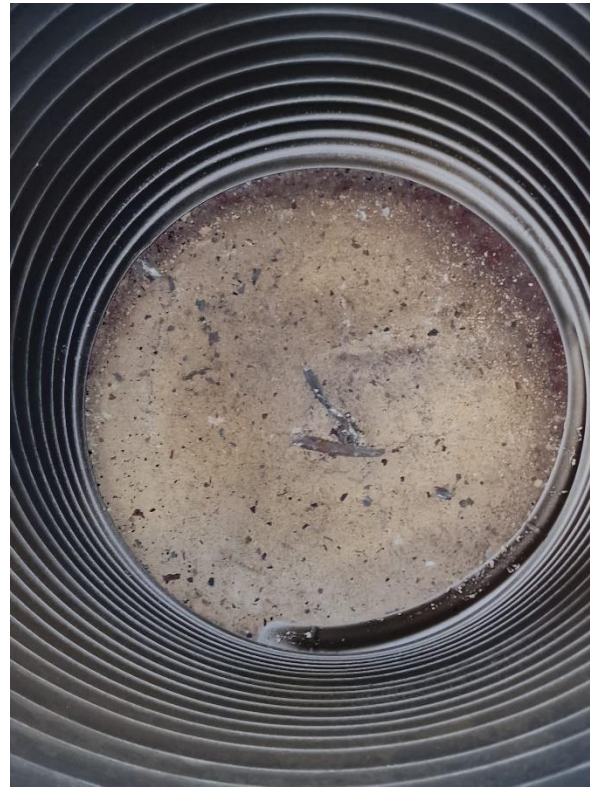
1. *General view of the boiler, bottom and upper refractory areas, found damaged*

1. The boiler was opened and internally cleaned. The soot deposit and other debris were cleaned by manual / mechanical brushing;
2. The old cement on the upper section, found worn and broken, was removed and the surface prepared for further cement replacement;
3. Refractory area was repaired according to the Maker's instruction. The damaged area was cleaned for loose particles and then coated with an air setting mortar, fine grain coating with approximately 74% Al<sub>2</sub>O<sub>3</sub> and a low iron content, temperature limit of approximately 1700°C.

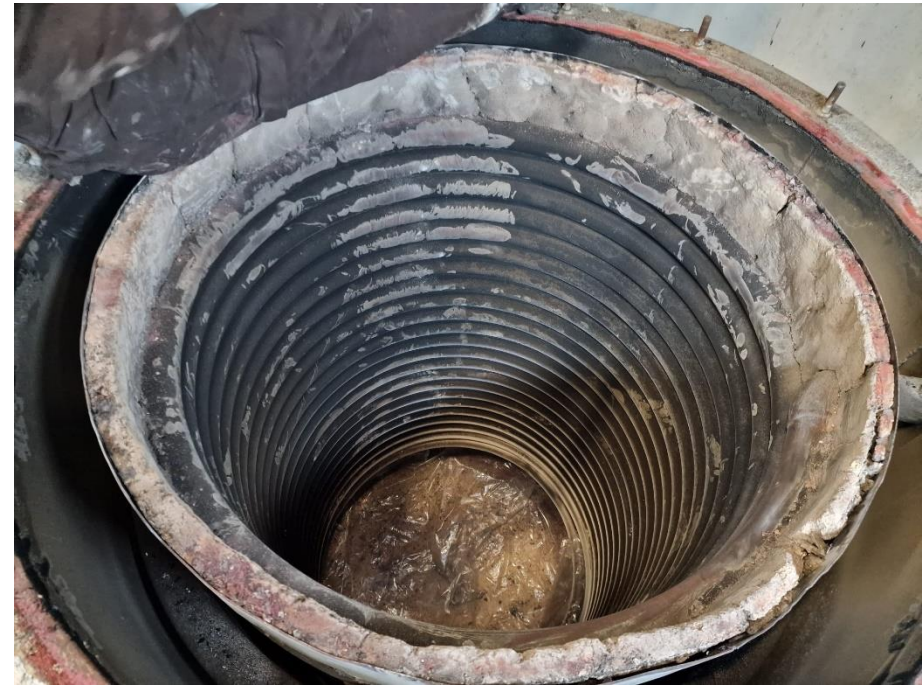
2. *Steel parts to be repaired by welding*

4. The existing steel ring in the seal box of the cover was removed.
5. In workshop, from mild steel bar 40 mm x 6 mm, it was prepared a new ring that replaced the old one and ensured a secure fit for the sealing mechanism;
6. The steel parts were inspected and any areas showing cracks or fractures were repaired by welding, restoring the boiler structural integrity;
7. A new seal, on the cover and body, were supplied and installed.

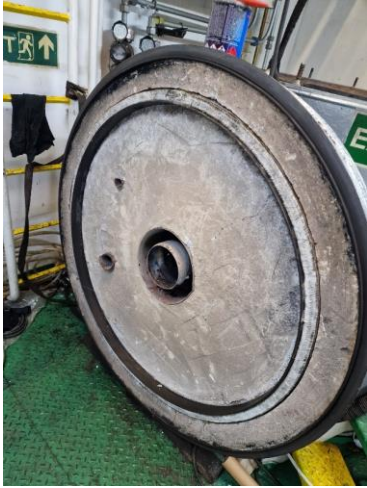
3. Boiler Cover repaired with new steel ring in the seal box.

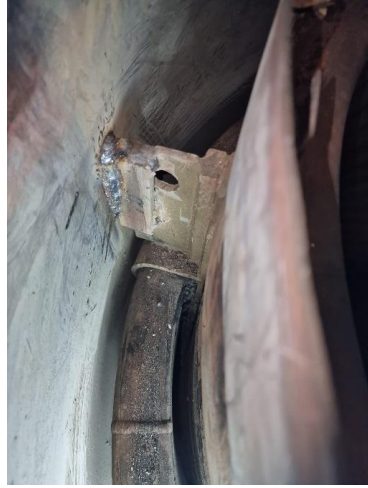
4. Internals already repaired by welding

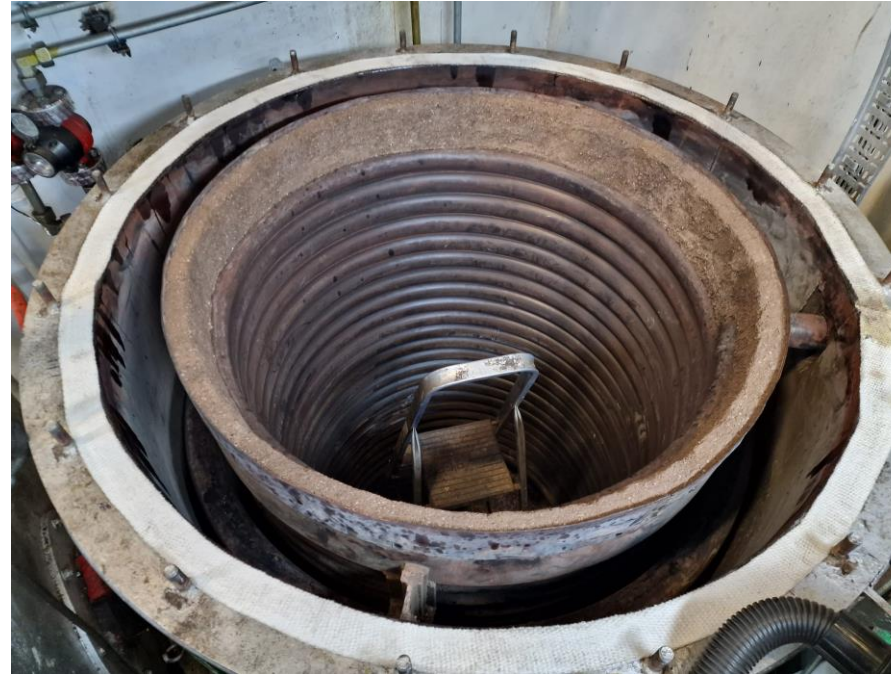
5. Refractory repaired. New seal applied on flange.

Refractory applied, CALDE PLAST SUPERAL X-AB.
