Case Study

Incinerator repair

Refractory replacement

Site Activity area Year	Setúbal - Portugal Incinerator repair 2023	Situation Incinerator refractory repair, on board a vessel berthed at Lisnave Shipyard – Setubal. Incinerator type ATLAS.
--	--	--

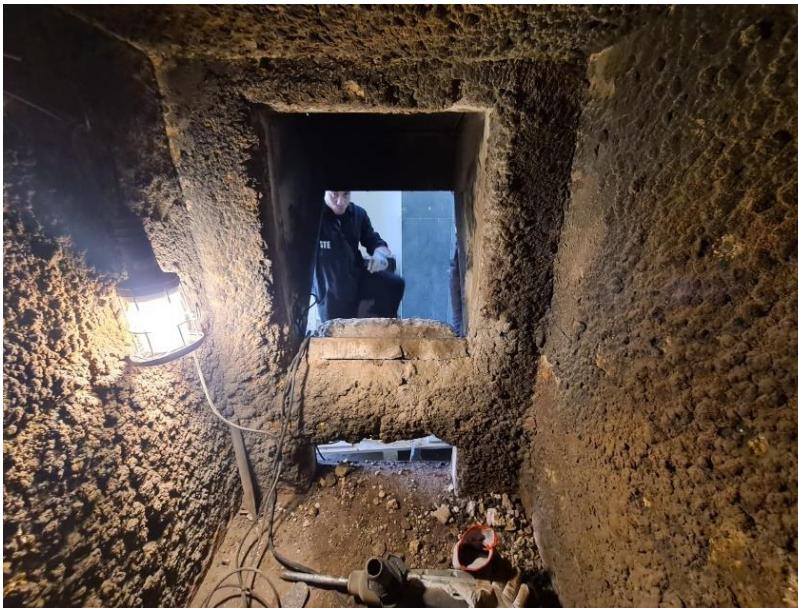
The Incinerator had several damages on both combustion chambers refractory walls and burner dumper, which needed to be completely rebuilt.

Incinerator inside view (Primary Chamber and Doors)

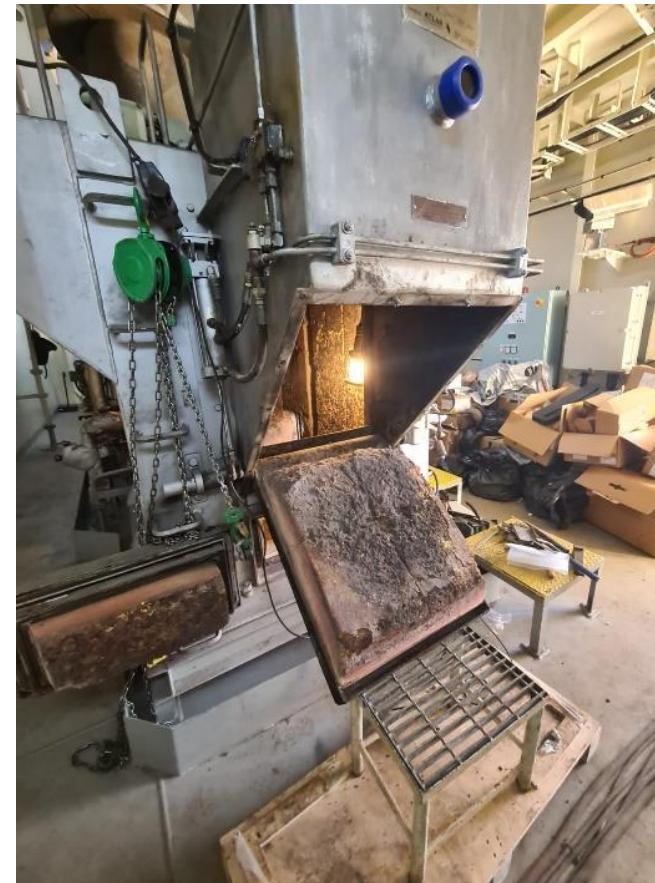
Waste Sluice Feeding Door before rebuilding

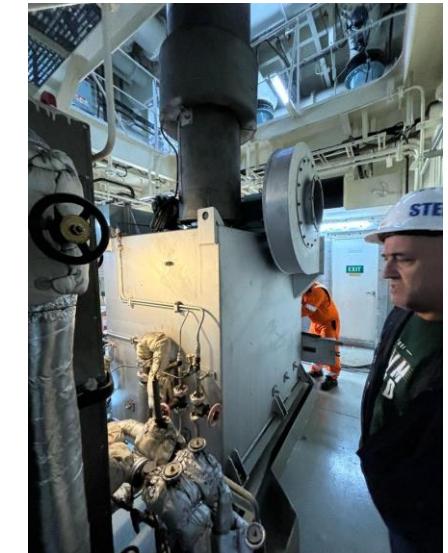
Initial inspection of the Incinerator

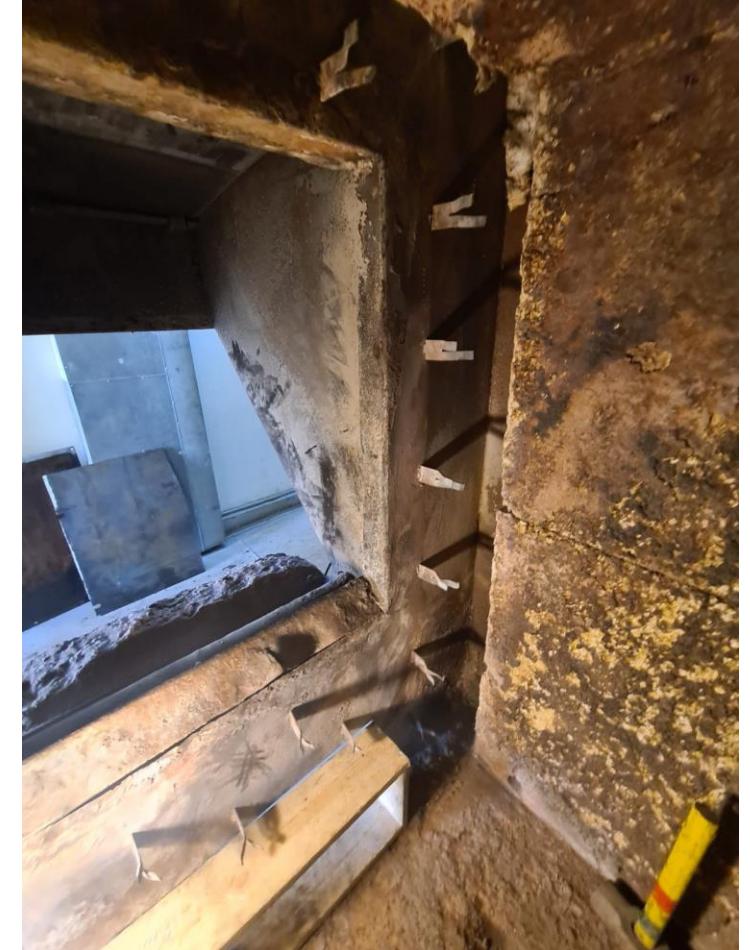
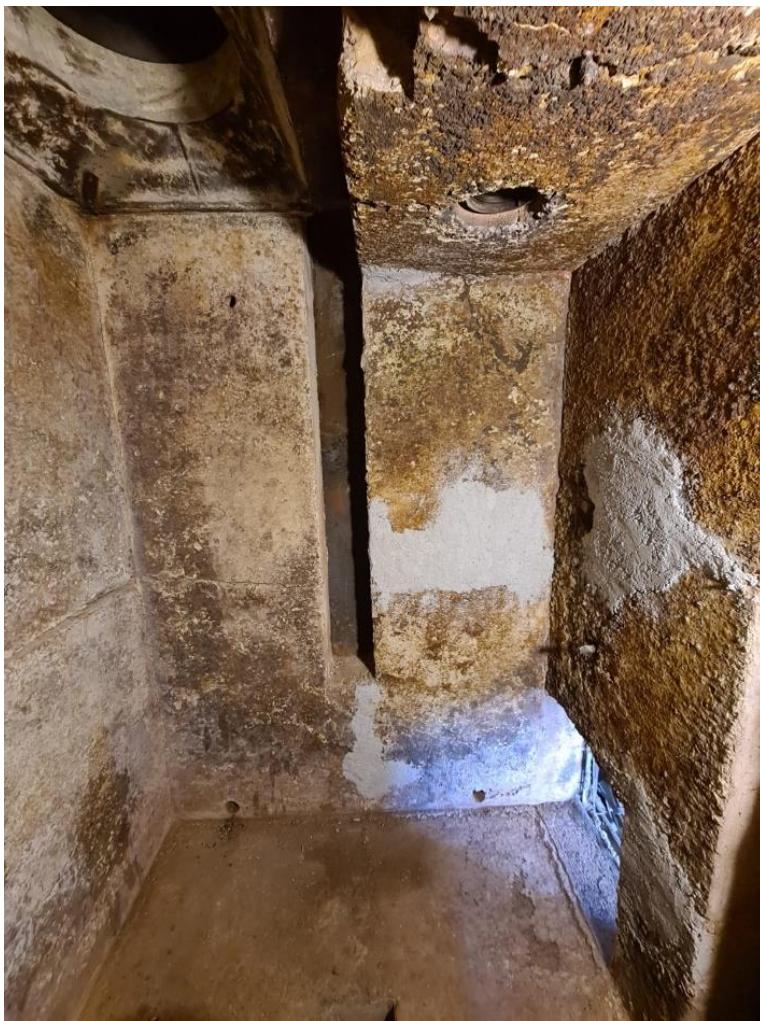
Work in progress. Repair of the walls

- 1 Removal of debris. The critical corrosion points and damages areas were repaired, with new steel inserts and welding.
- 2 The internal steel anchors were renewed (necessary to support the new refractory castable).
- 3 The Big and Small Partition Walls were rebuilt, according to the original configuration.
- 4 On furnace walls and floor, as per the Maker's Instructions, it was applied aprox. 450 kg of new refractory castable (type Calde Patch PB 82 U, AbCrete A60 Cast and Calde Plast Superal X AB).
- 5 The walls were kept drying for about 12 hours with the burner shutters opened to allow circulation of air.
- 6 A final inspection and test run were performed with good results. No defects or cracks were found.

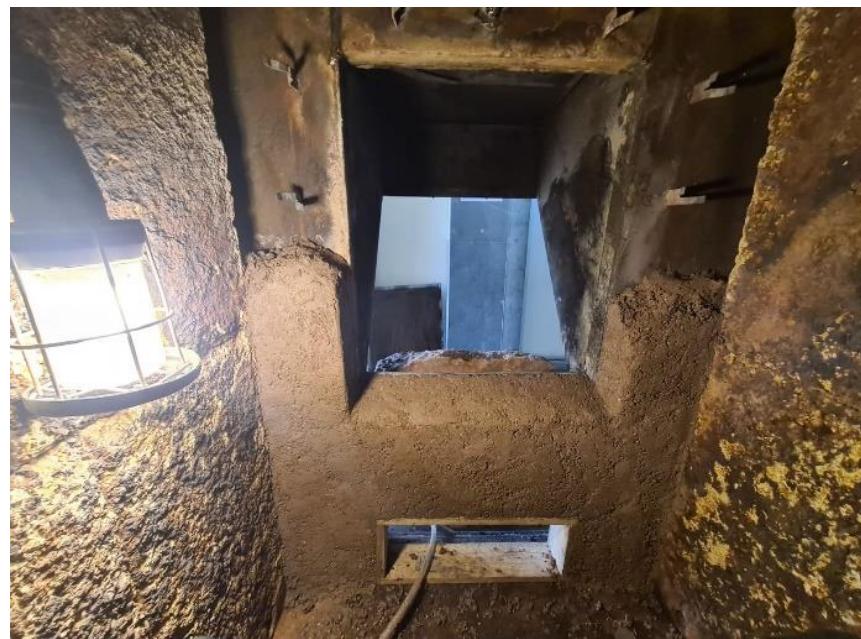
New refractory castable application

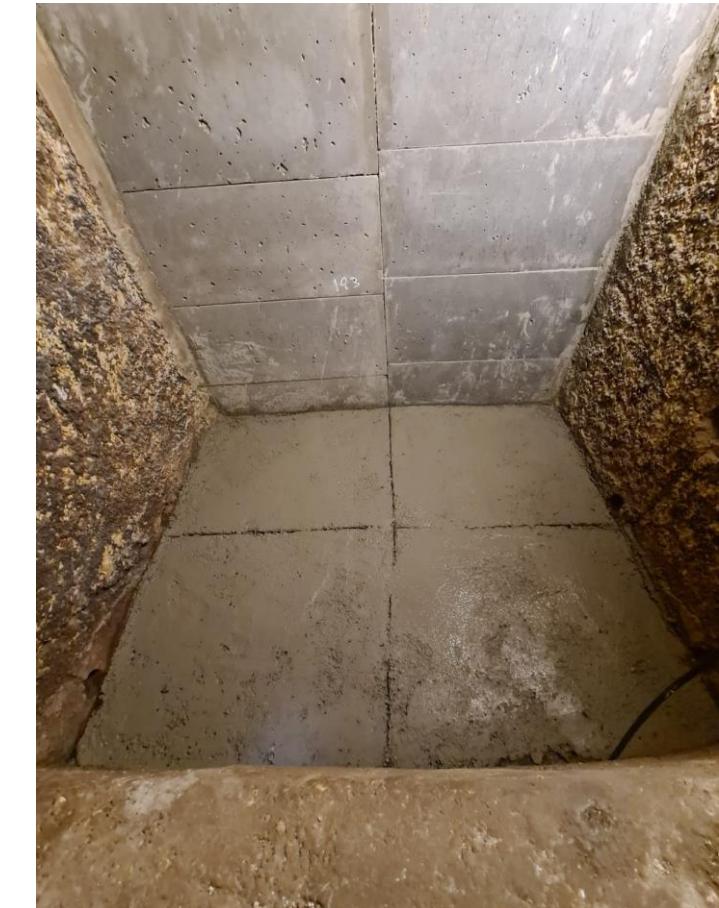
Rebuilding walls and floor

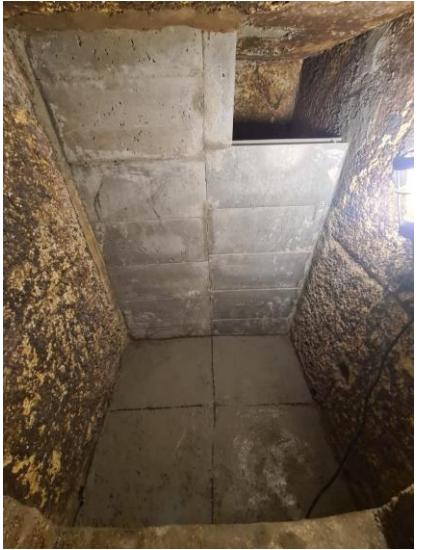
View of the new Big Partition Wall

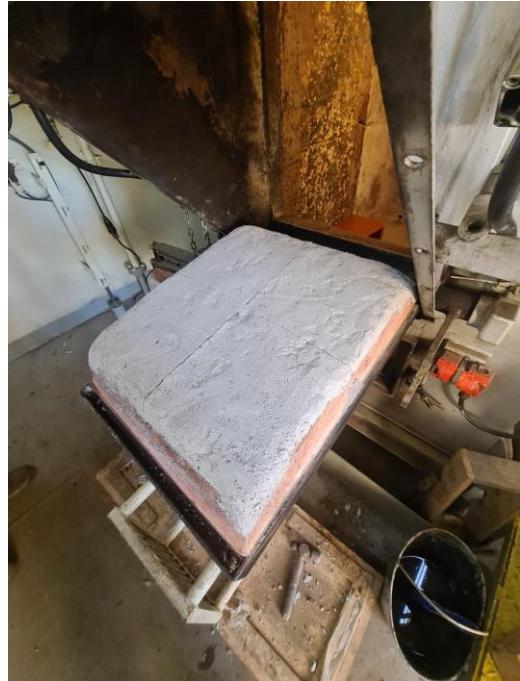
Ash Door already renewed

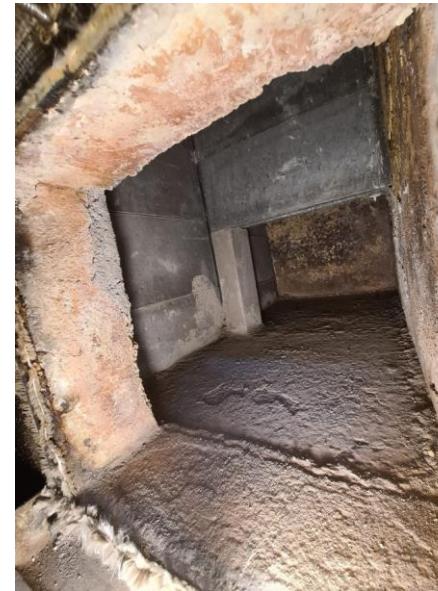
New Secondary Chamber wall

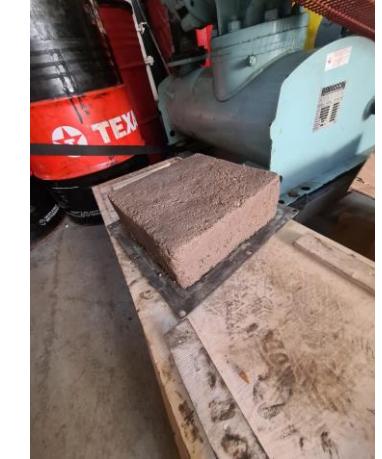
Rebuilt Secondary Door
