## ALTERNATOR OVERHAUL

Requested an Alternator Overhaul for the Guanaterme vessel.

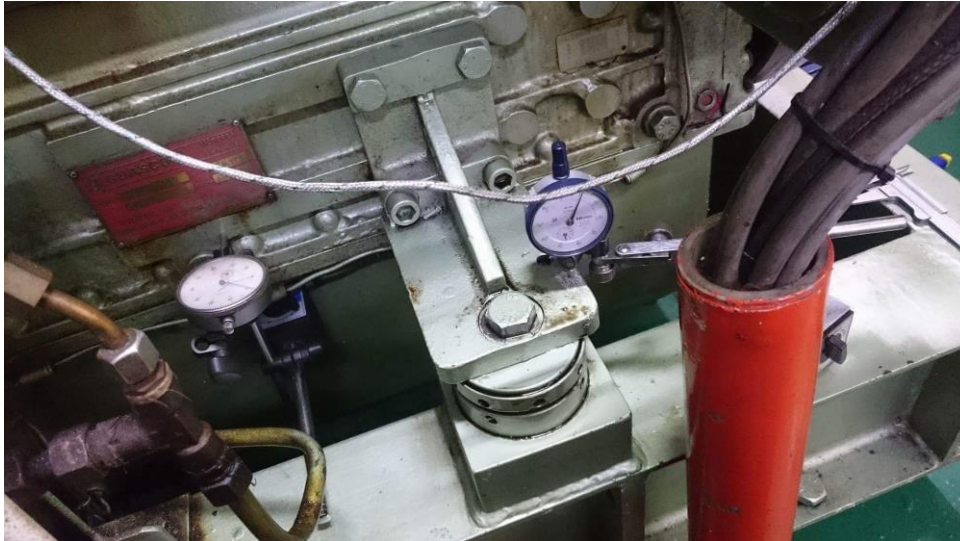
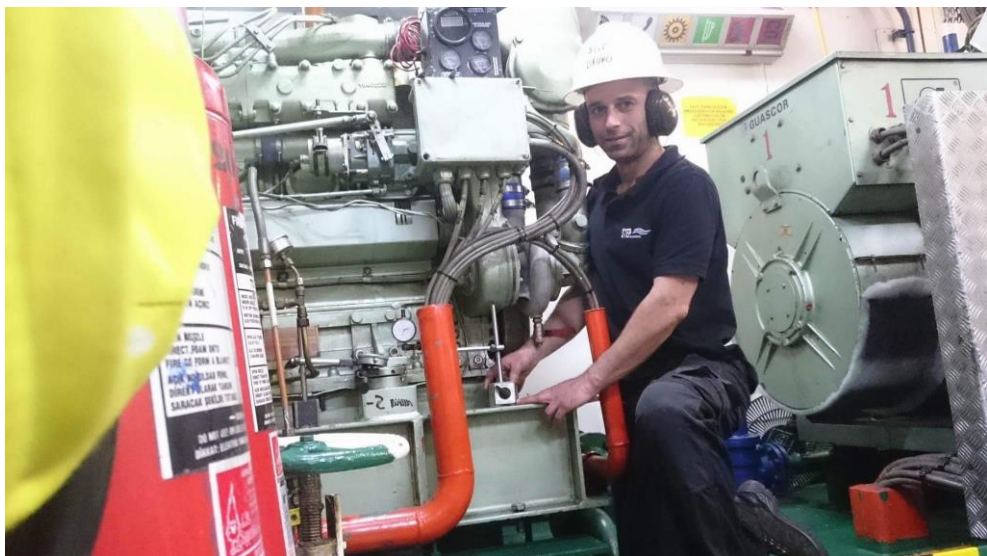
The alignment problem was originated by a unscrewed blocking bolt that affected the stability of the system. This cause an increase of the natural vibration, causing the alignment problem. Situation successfully corrected. All works have been executed as required.
